AVIATION INVESTIGATION REPORT

A03O0012

LOSS OF CONTROL – COLLISION WITH TERRAIN

PROVINCE OF ONTARIO,
MINISTRY OF NATURAL RESOURCES
EUROCOPTER AS 350 B2 (HELICOPTER) C-GOGN
MEKATINA, ONTARIO
21 JANUARY 2003

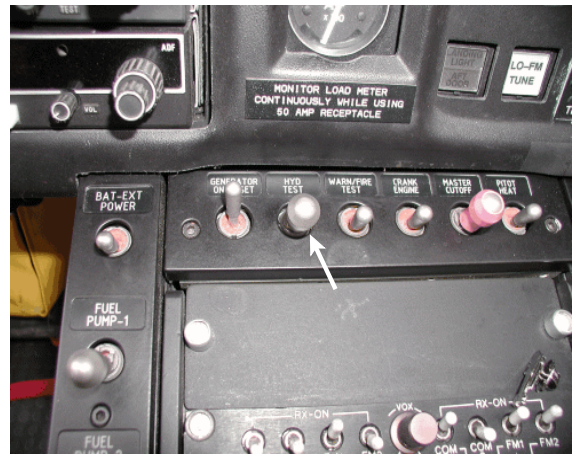
The HYD TEST switch (Photo 3) was found in the forward or “Test” position. The pull-to-unlock design of the HYD TEST switch requires the toggle lever to be lifted up, then over the locking mechanism. Impact marks on the switch indicate that it was likely in the forward position at the time of impact. A continuity check and function testing were performed on the switch and no discrepancies were noted. This switch is powered through the hydraulic CB.

Photo 3. Hydraulic HYD TEST switch

At some point prior to the crash, the pilot moved the HYD TEST switch to the "Test" position. This is not recommended in flight and would normally result in the loss of hydraulic pressure in the tail-rotor servo system. However, it appears that the hydraulic CB was already tripped when the HYD TEST switch was moved. This is supported by the presence of hydraulic pressure in the tail-rotor servo accumulator after the occurrence; this pressure would have provided for tail-rotor yaw control.
